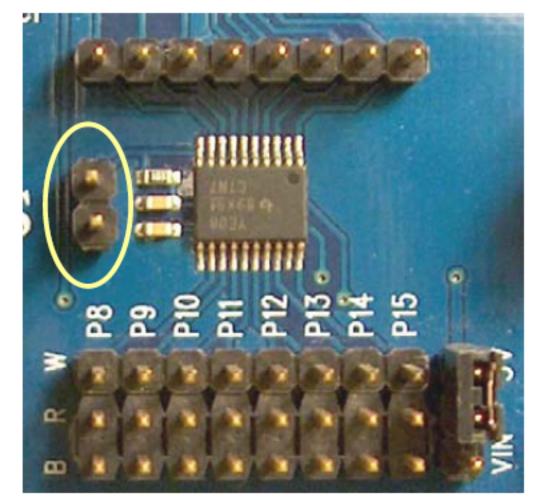
Translator Enabled

8-pin bypass header and 2pin translator header installed. Jumper *not* installed.

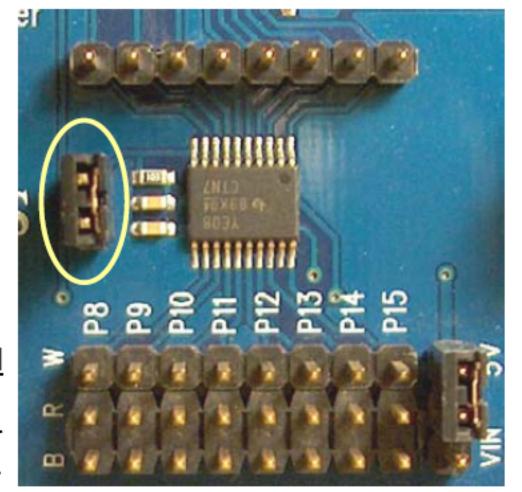
Translator Disabled

Jumper installed on 2pin translator header.
